**Report No. 10CFR21-0083**

### 10CFR21 REPORTING OF DEFECTS AND NON-COMPLIANCE

COMPONENT: Pistons used in EMD 645 series engines

SYSTEM: EMD diesel generators

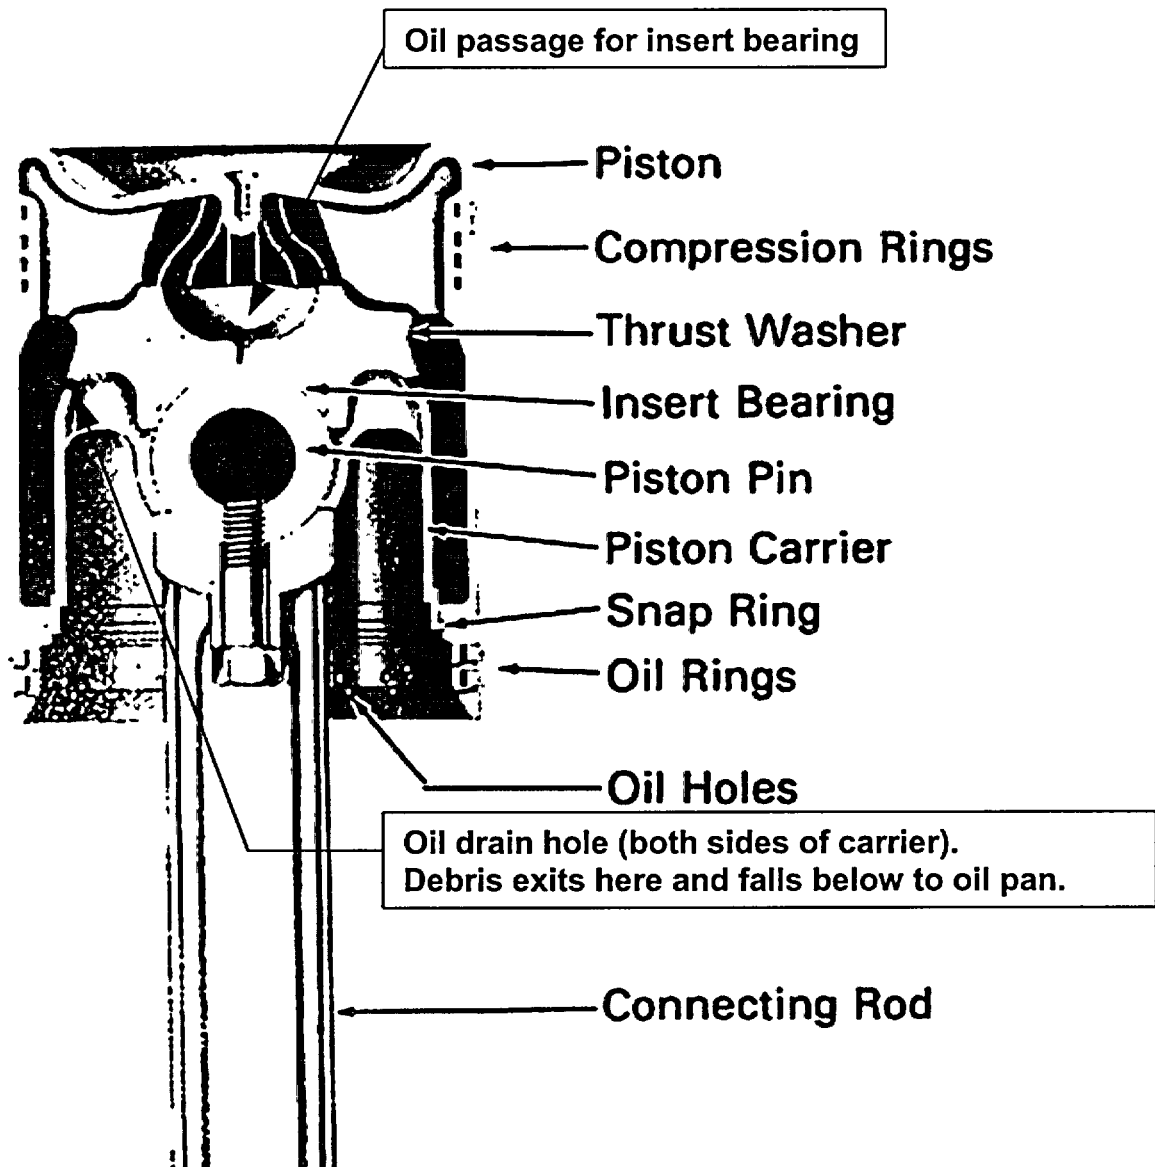
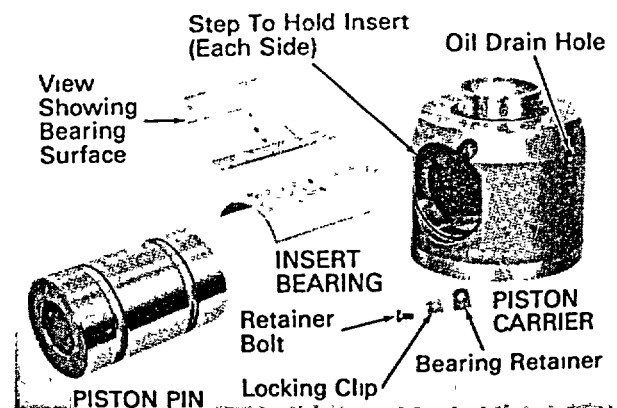
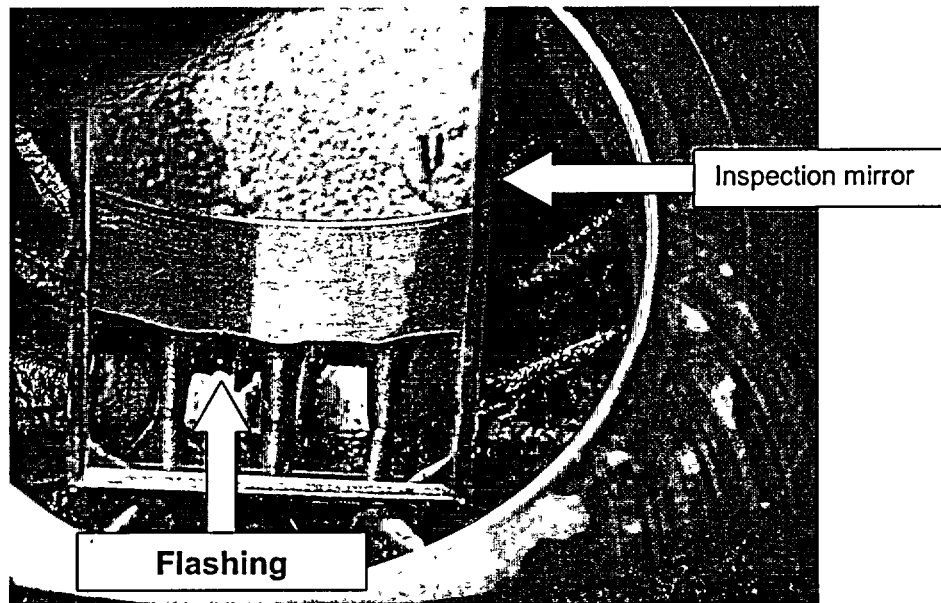
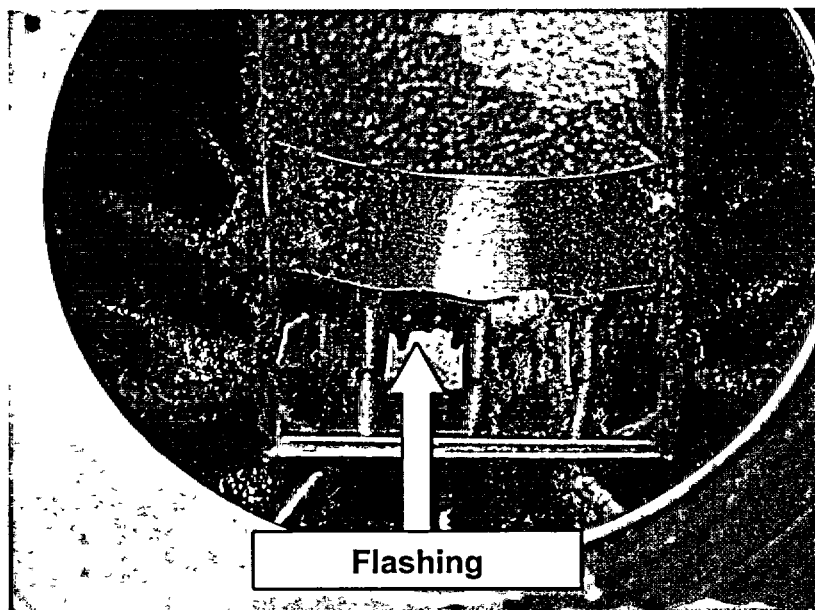
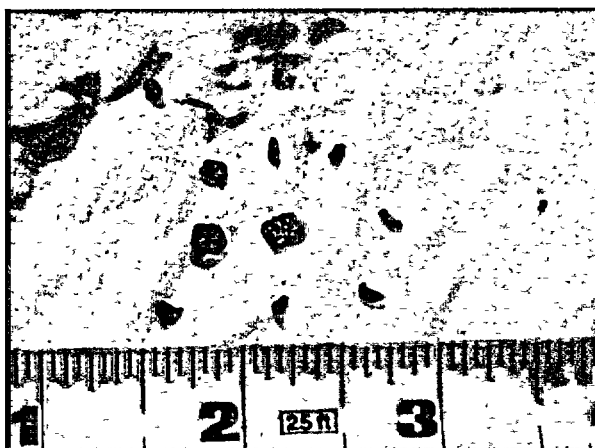
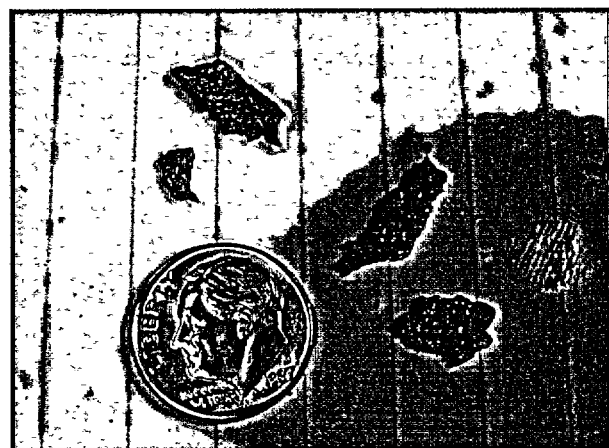
Engine Systems Inc. (ESI) has concluded our investigation of a condition reported with EMD pistons applicable to EMD 645 engines. The condition identifies casting flash material on the underside of the piston crown between the gussets (crown windows). The flash is a product of the piston manufacturing process when the piston cores are joined together. Internal parts of the piston are lubricated and cooled by the piston cooling oil. Cooling oil is directed through a drilled passage in the piston carrier and circulates about the underside of the piston crown area. Some of the oil lubricates the insert bearing and piston pin through an oil passage in the carrier and the remaining oil drains through two holes in the carrier located at the taper (refer to illustration on the next page). Any loose flash material that may become dislodged is carried by the oil through the piston carrier drain holes and settles at the bottom of the oil pan. The settled fragments are not of concern. There exists a concern, however, that a loose fragment could block the insert bearing oil passage and thus cause bearing damage. EMD has reported that no failures have been attributed to this condition (nuclear or commercial applications) to date.

- Point Beach nuclear plant originally reported such a condition in January 2002. During maintenance activity when engine lube oil was removed, small metallic fragments (1/4" to 1/2") were recovered from the oil pan. Some of the fragments were located directly below cylinders 9 & 19. Subsequent inspection of the cylinder 9 & 19 power assemblies revealed flashing on the piston underside area near the piston crown webbing that broke away when touched by hand. The remaining 18 power assemblies were then removed for evaluation. Insert bearing inspections revealed no abnormal conditions relating to the metallic fragments. The pistons were supplied in 1999 as part of 20 complete power assemblies. 14 of the 20 assemblies had some degree of flash material with 10 of those exhibiting loose pieces that could be flaked off using a small hand tool. All pistons were identified with 1999 serial numbers. The flash condition was thought to be limited to this batch of pistons.

- Recently (July 2002), Nine Mile Point reported metallic fragments in the engine oil pan. The fragments were located below 6 cylinders and resemble those found in the Point Beach engine. The pistons are identified with 1997 and 1998 serial numbers.

1. **Monitor lube oil for trend of increasing silver levels.** Review previous lube oil analyses and perform a lube oil analysis after each surveillance run. If silver concentration increases 0.2 ppm or greater between runs or if silver concentration is greater than 1.0 ppm, perform lead wire readings. Perform insert bearing inspections for any cylinders with unacceptable lead wire readings. Piston underside crown inspection (see below) shall be performed as soon as possible if any cylinder has insert bearing damage that is attributed to flash material.

2. **Check oil pan for metallic fragments at earliest convenience** (see note below).
  - a. **If metallic fragments are discovered**, perform the following:

- i. **Continue monitoring lube oil for any trend of increasing silver levels** (see above).
    - ii. **Perform piston crown inspections during next refuel outage.** Use an inspection mirror or boroscope to completely examine the underside of the piston crown. Flashing material that is tightly adhered and does not easily break off by exerting force from a finger or a hand held tool is considered acceptable.
